URBAN WATERSHED MANAGEMENT IN THE BRAZILIAN AMAZON

The Tucunduba Hydrographic Basin (THB) is the second-largest basin in Belém, Pará, draining four densely populated neighborhoods—Marco, Canudos, Terra Firme, and Guamá—with an estimated population of approximately 200,000 inhabitants. This study aims to analyze the socio-environmental conditions of the THB by examining key macro-environmental factors essential to understanding the basin's dynamics. The methodological approach involved conducting 44 interviews with THB residents to assess their socio-environmental perceptions, applying the Simplified Environmental Impact Assessment (SEIA), and estimating per capita sewage discharge across the neighborhoods within the basin. The findings indicate that the Quality of Urban Life Index in the study area is approximately 0.6, reflecting moderate living conditions. The SEIA further revealed substantial environmental impacts, classified as high or very high. These results underscore the inadequacy of public services provided to the local population and highlight the fragility of urban management. Urgent measures are needed to implement an integrated management strategy for the THB, enhanc

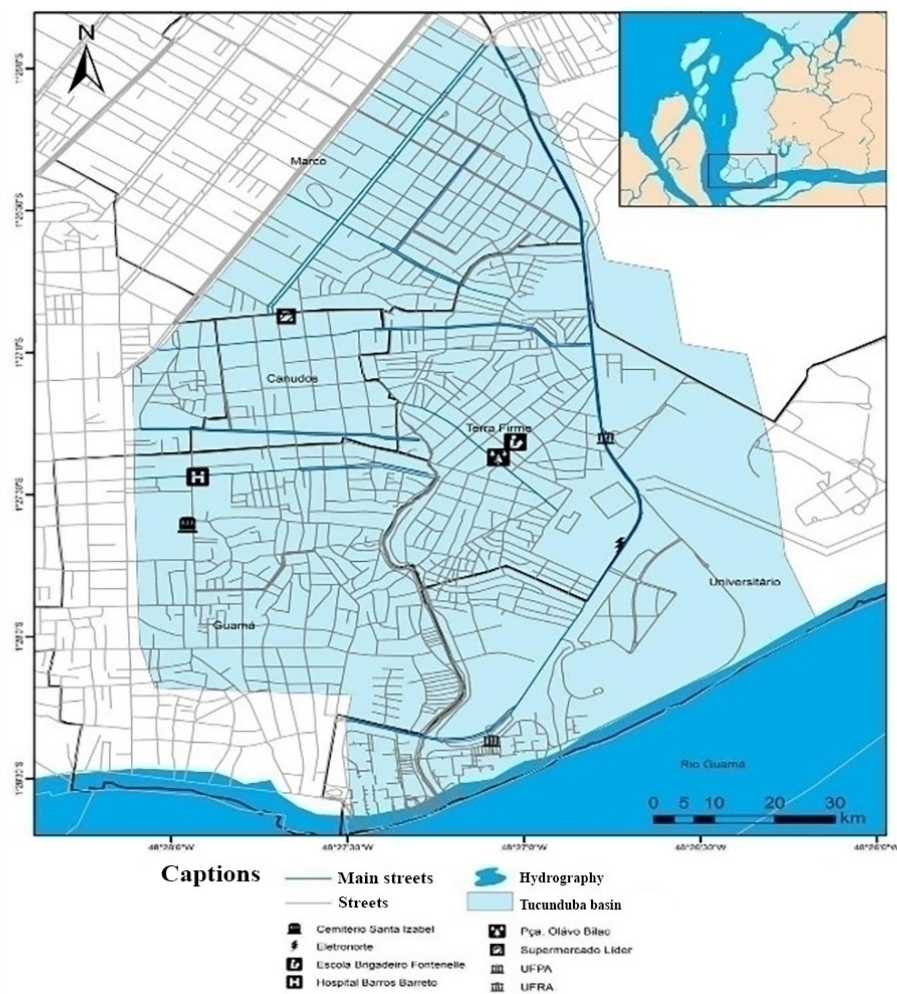
Figure 1 - Map of the Tucunduba River Basin. Source: Adapted from CODEM (2014).

The Tucunduba Hydrographic Basin is situated in the southern area of Belém, covering a total area of 10.55 km² and 3,600 meters (see Figure 1).

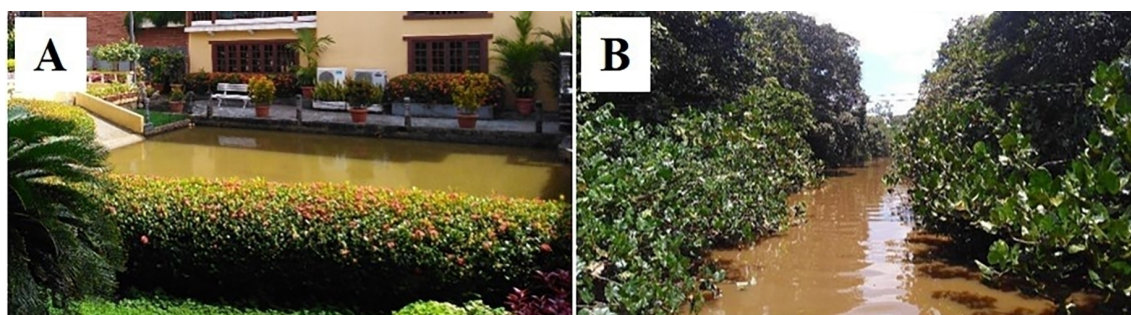
Figure 2 - Sections of the Tucunduba River; A) Source of the Tucunduba river inside private property and B) Mouth of the Tucunduba river. Source: Authors.

The neighborhood of Marco is situated at one of the sources of the Tucunduba River on Lane Angustura, between Avenue Almirante Barroso and Avenue João Paulo II (see Figure 2A). The mouth of the Tucunduba River is located within the territory of the Universidade Federal do Pará, on the right bank of the Guamá River (see Figure 2B).

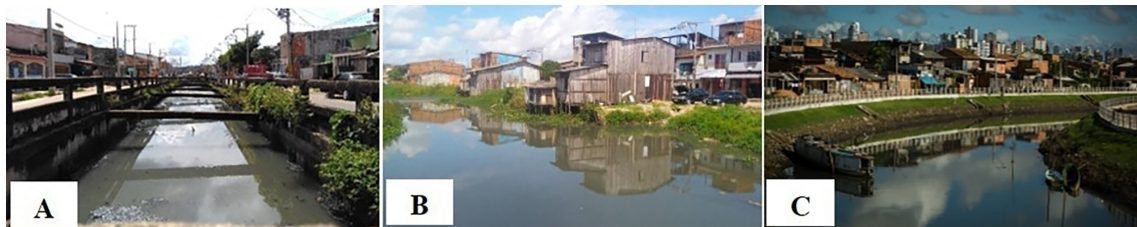
Figure 3 - Sections of the Tucunduba River A) Cipriano Santos Canal, Canudos neighborhood. B) Avenue Celso Malcher, Terra Firme neighborhood 2018. C) Passagem Tucunduba, Guamá neighborhood. Source: Authors.

Along the basin, each neighborhood has unique characteristics shaped by urban interventions that modify the landscape and land uses, as illustrated in Figure 3A for the well-known Cipriano Santos Canal in the Canudos neighborhood, Figure 3B for Avenue Celso Malcher in the Terra Firme neighborhood, and Figure 3C for Passagem Tucunduba in the Guamá neighborhood. These figures show the neighborhoods at distinct stages /of development.

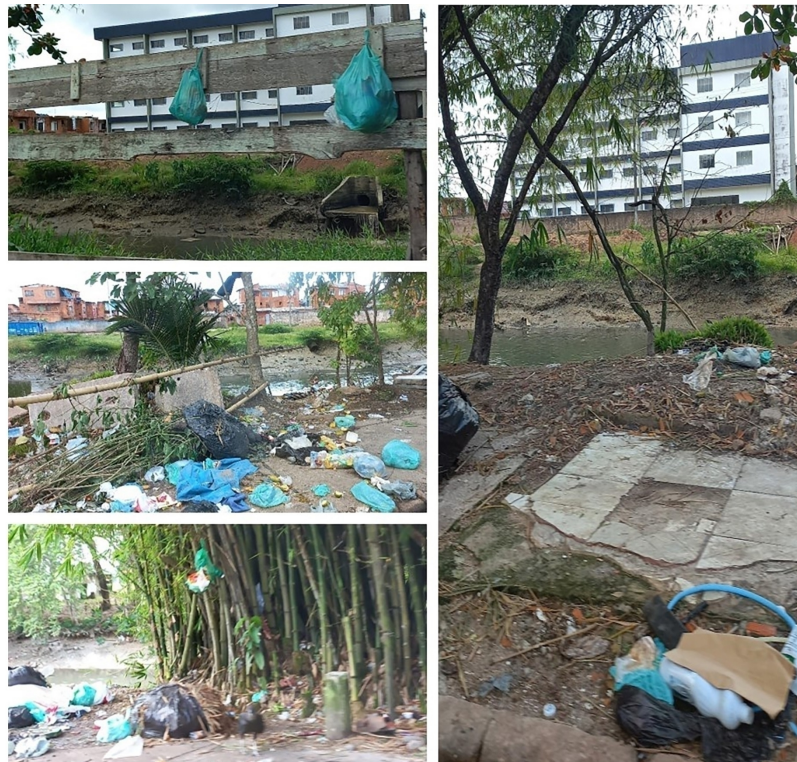
Figure 4 - Photos depicting the disposal of waste on the margins of the Tucunduba River in Section 1 of Stage 1. Source: Authors.

The interviewees reported that, in this scenario, the accumulation of waste in inappropriate places (see Figure 4) could be even more aggravated and could lead to its transport to the watercourse, especially during heavy rains and flooding.

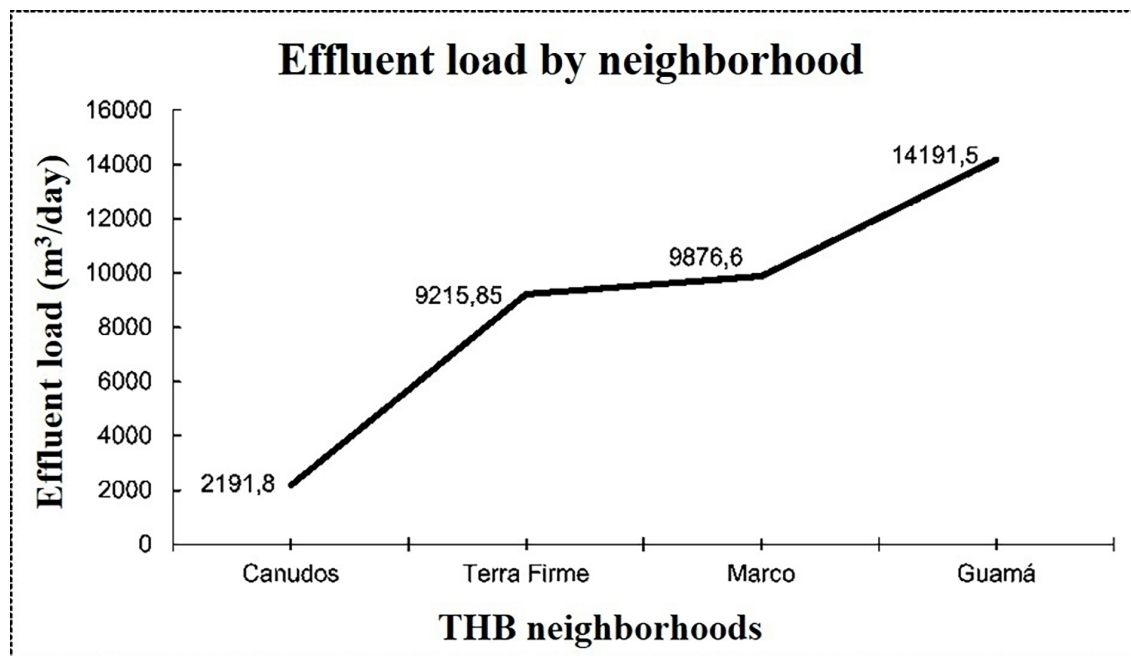
Figure 5 - Load of effluents by neighborhood on the Tucunduba River Basin. Source: Authors.

In the neighborhoods of Terra Firme and Marco, it is estimated that 9,216 m³/day and 9,877 m³/day of effluents are produced, respectively, requiring treatment or proper disposal (Figure 5).
